Manhole Inspection Summary

Manhole # S31I__002MH

Insp Date: **12/31/08 10:47 AM**

Location Address: **22 W.Lomard St.**

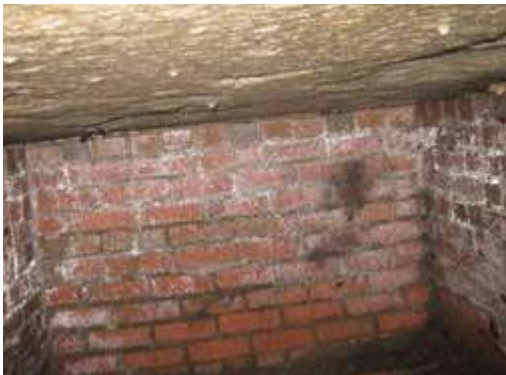
Misc

in barrel rectangular vault

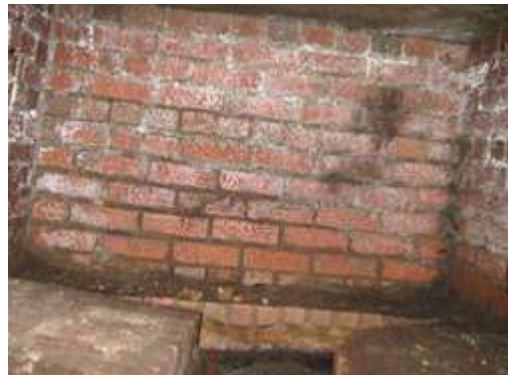
Misc

in barrel under the flat top

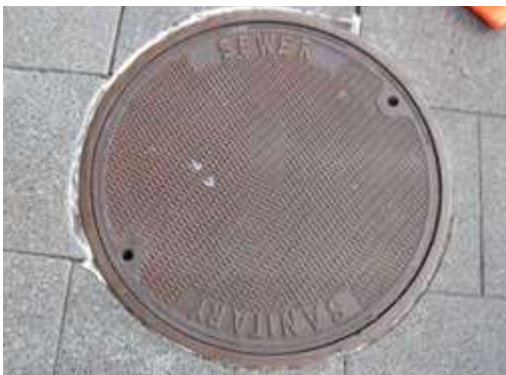
Misc

cover

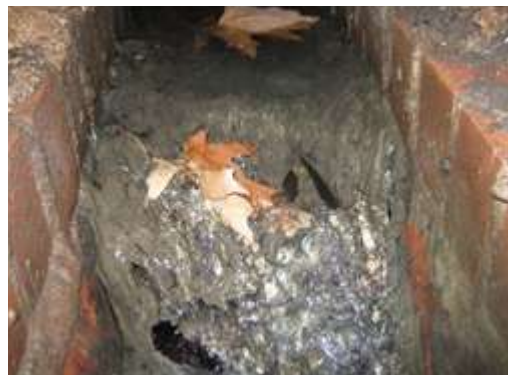
Defect 4

Condition: ☐ Sound ☐ Cracked ☐ Root Intrusion ☐ Deteriorated ☐ Leaks ☒ **Debris**

channel debris

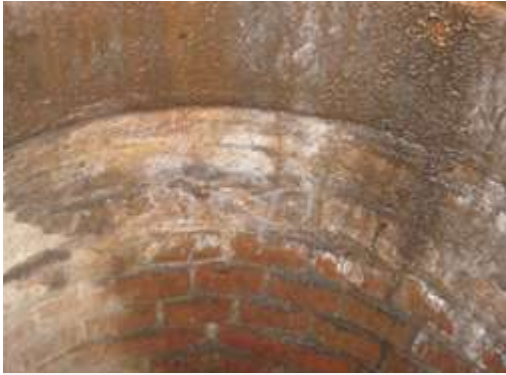
Defect 3

Frame Offset: **0** (in.) Condition: ☐ Sound ☐ Cracked ☒ **Leaks**

Infiltration: ☐ None ☒ **Joint** ☐ Cracks ☒ **Mortar** ☐ Roots ☐ Wall

chimney missing mortar at frame joint,
chimney infiltration at frame joint

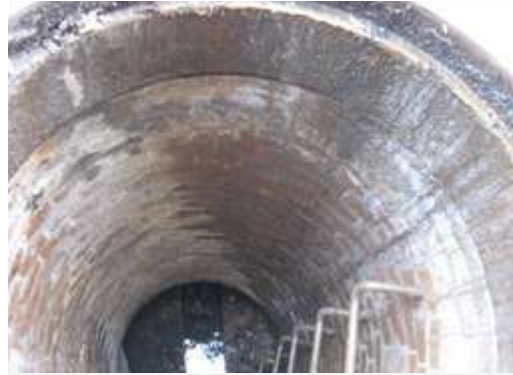
Defect 2

Infiltration: ☐ None ☐ Joint ☐ Cracks ☐ Mortar ☐ Roots ☒ **Wall**

chimney and corbel infiltration

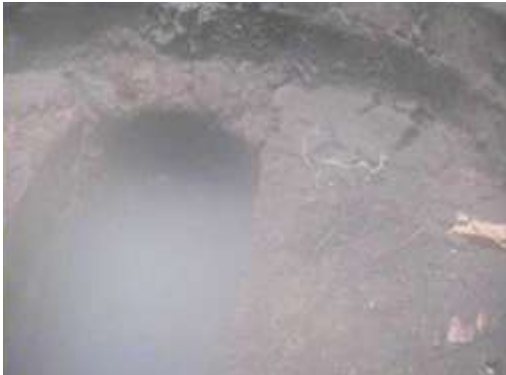
Defect 1

Condition: ☐ Sound ☐ Cracked ☐ Root Intrusion ☐ Deteriorated ☐ Leaks ☒ **Debris**

bench debris

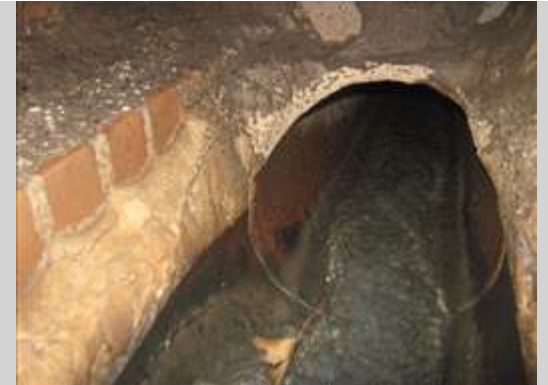
12 O'Clock Outflow

10 in. Circular Gravity Sewer
Pipe Out @ 12 O'Clock

Infiltration: **None** Pipe Seal Cond: **Sound**

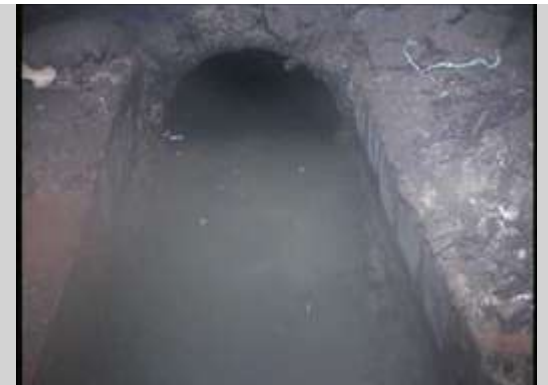
3 O'Clock Inflow

8 in. Circular Gravity Sewer
Pipe In @ 3 O'Clock

Infiltration: **None** Pipe Seal Cond: **Sound**

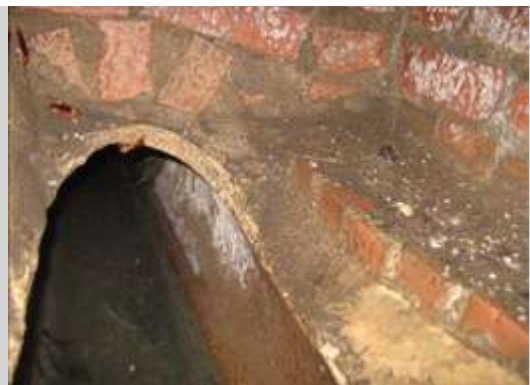
6 O'Clock Inflow

10 in. Circular Gravity Sewer
Pipe In @ 6 O'Clock

Infiltration: **None** Pipe Seal Cond: **Sound**
